**EXPERIMENTAL BEHAVIOR OF GRAPHITE-EPOXY Y-STIFFENED
SPECIMENS LOADED IN COMPRESSION**

P. D. Sydow and M. J. Stuart
NASA Langley Research Center
Hampton, Virginia

An experimental investigation of the behavior of graphite-epoxy Y-stiffened specimens loaded in compression is presented. Experimental results are presented for element specimens with a single stiffener and for panel specimens with three stiffeners. Response and failure characteristics of the specimens are described. Effects of impact damage on structural response for both specimen configurations are also presented. Experimental results indicate that impact location may significantly affect the residual strength of the Y-stiffened specimens. The failure results indicate that the critical failure mode is buckling of the stiffener webs for Y-stiffened element specimens and buckling of both stiffener web and stiffener blade for the Y-stiffened panel specimens.

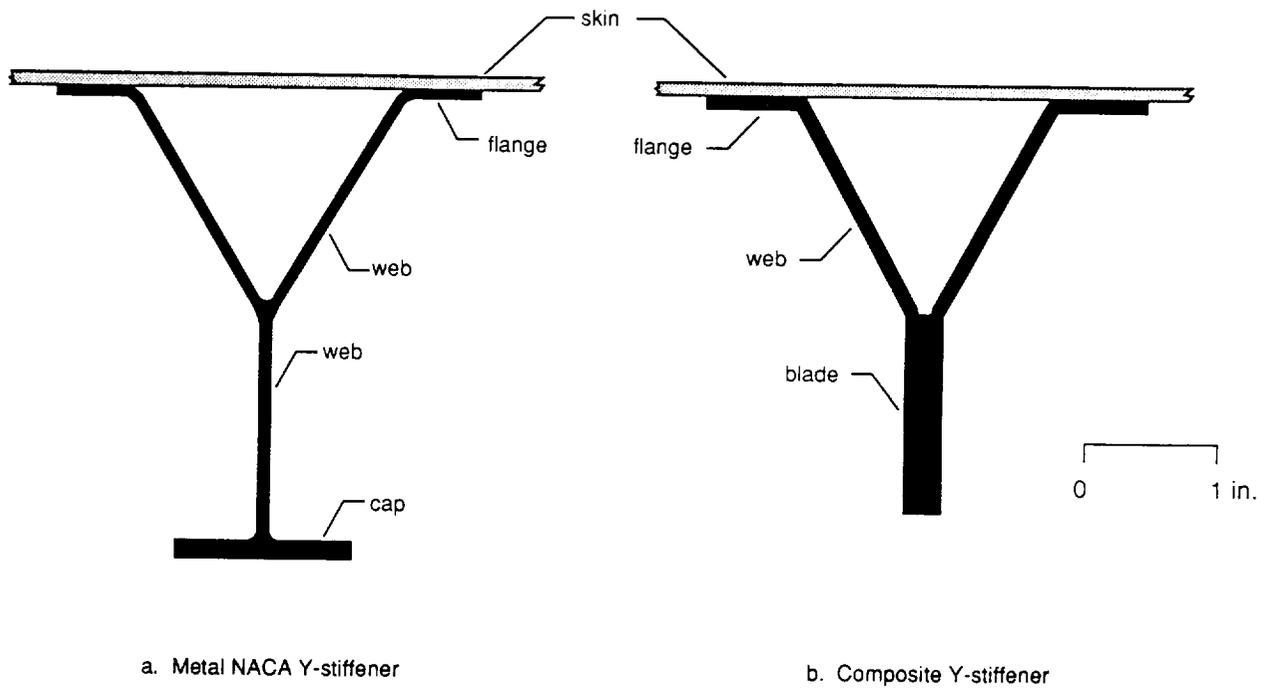
Figure 1. Y-Stiffener Configurations.

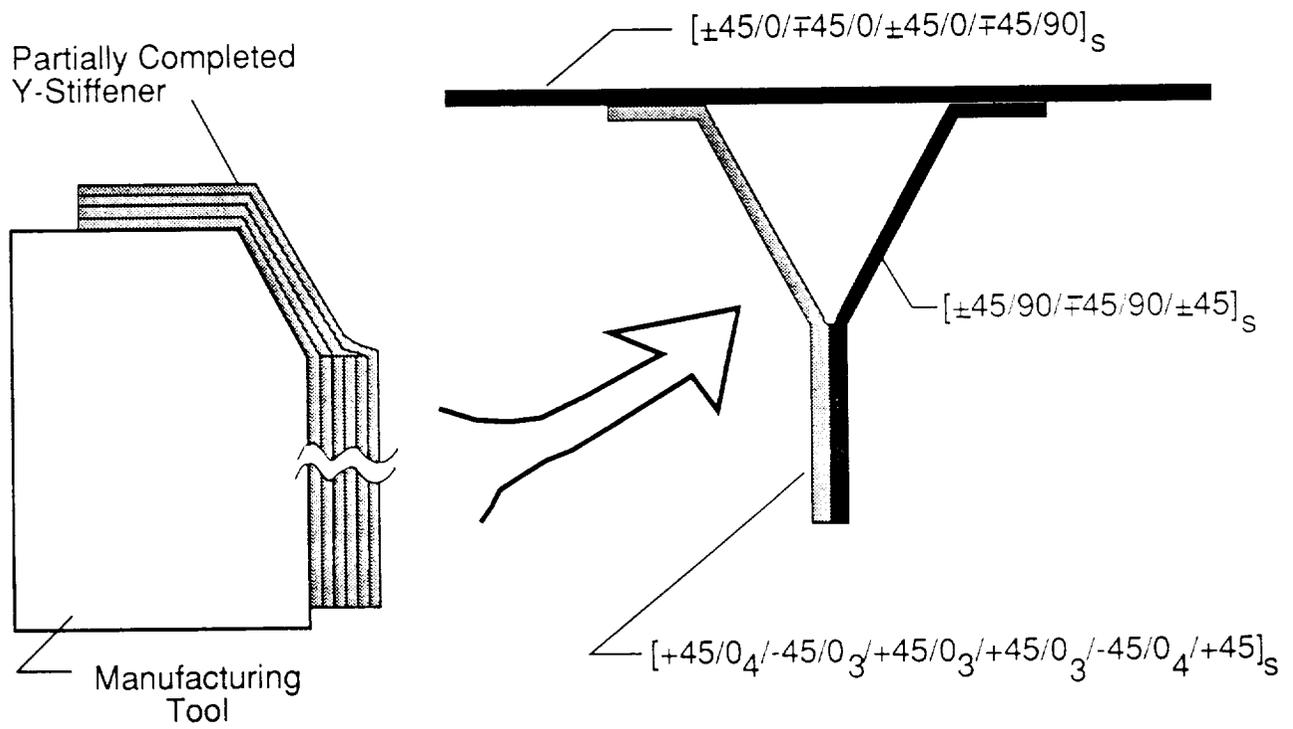
Figure 2. Fabrication of Composite Y-Stiffened Element.

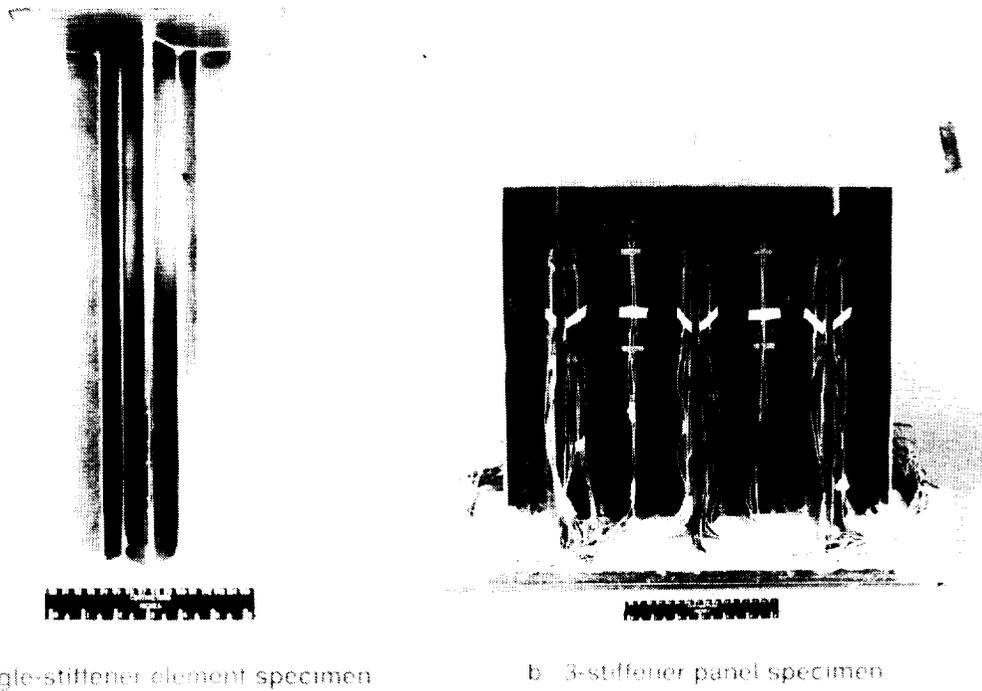
a Single-stiffener element specimen

b 3-stiffener panel specimen

Figure 3. Y-stiffened specimens.

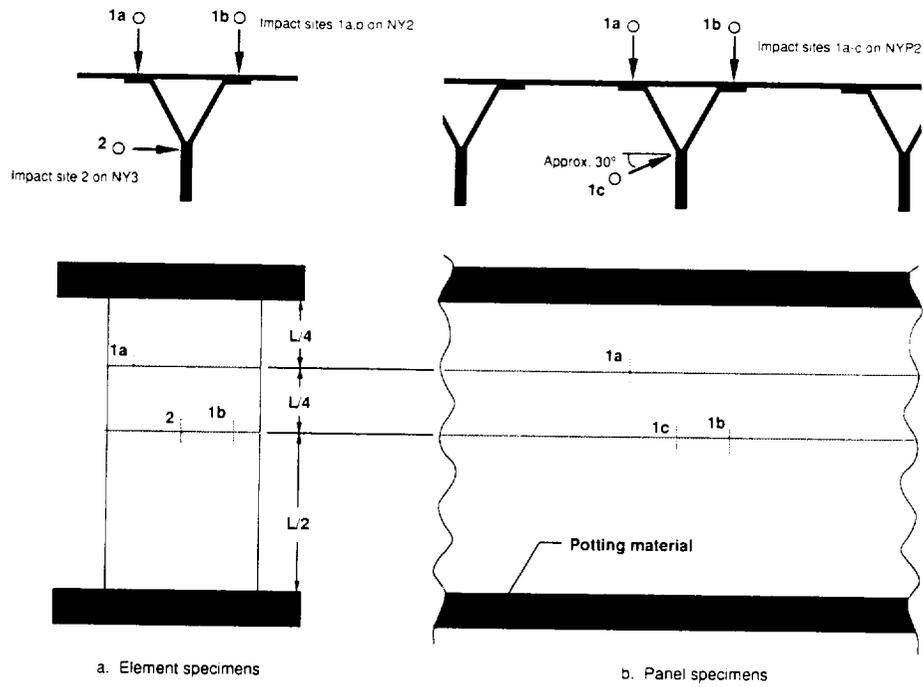
Figure 4. Impact sites for Y-stiffened specimens.

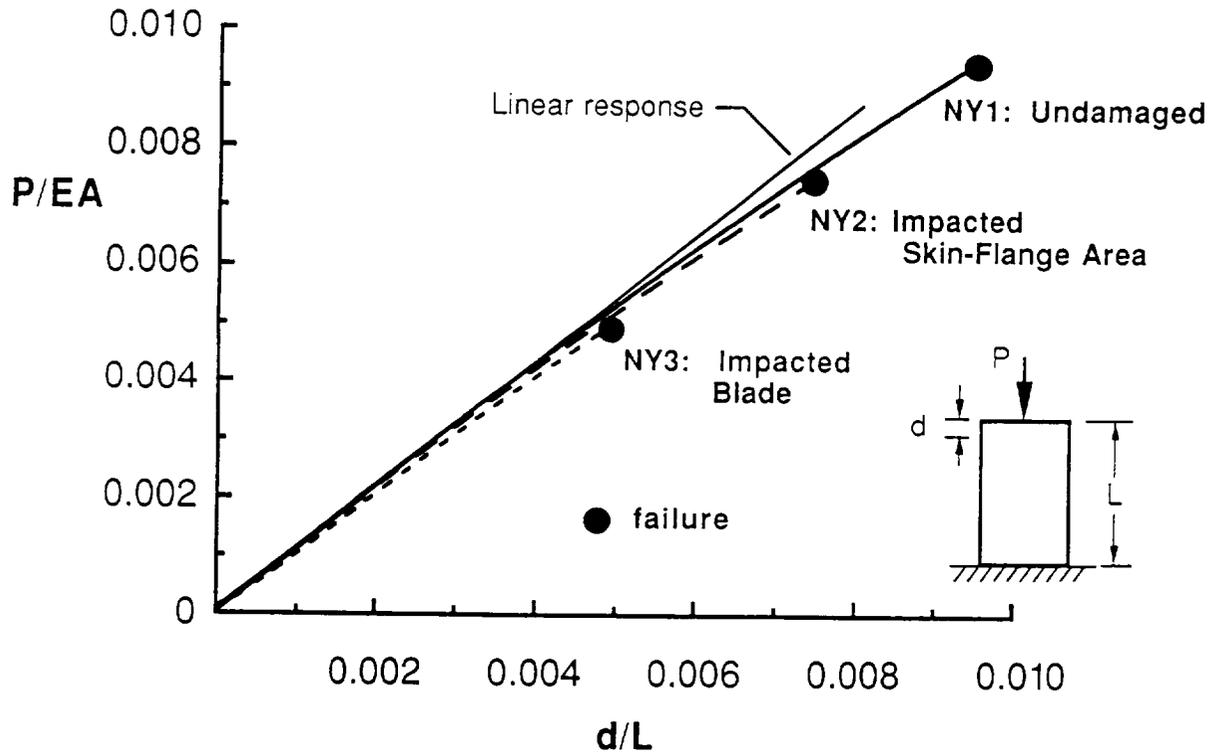
Figure 5. Normalized load versus end-shortening for Y-stiffened element specimens.

Curves of normalized load versus end-shortening are presented in Figure 5 for the three Y-stiffened element specimens. The applied load P is normalized by the membrane stiffness EA and the end-shortening d is normalized by the specimen length L . This normalized end-shortening d/L is a measure of the specimen's average axial strain. The filled circles appearing in the figure indicate specimen failure.

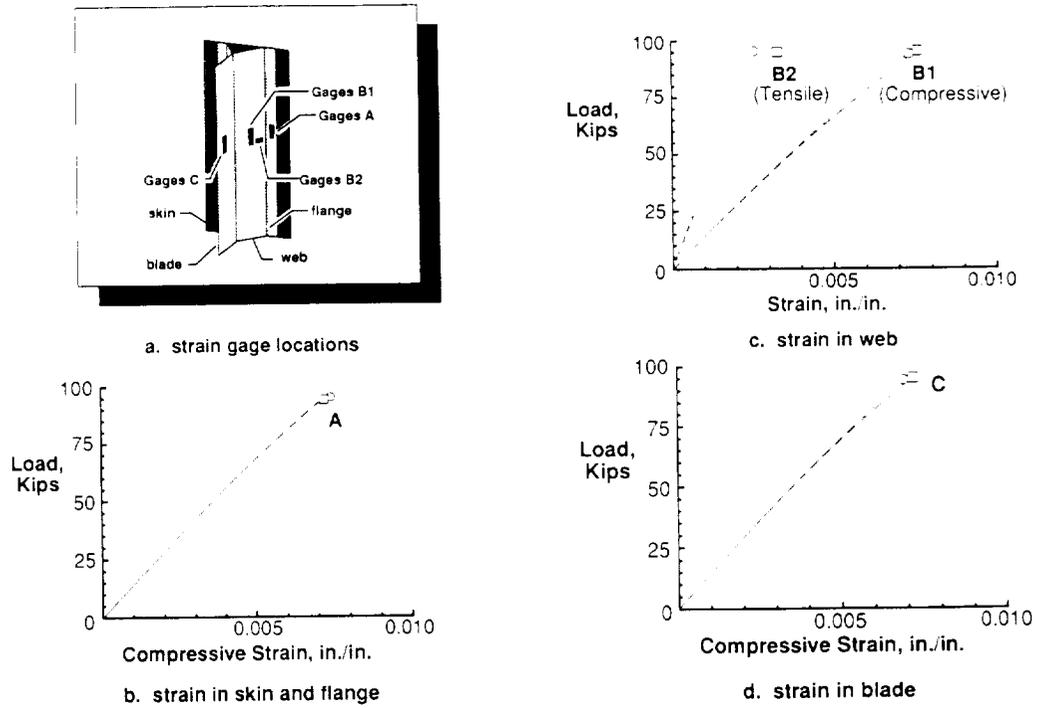
Figure 6. Strain gage results for undamaged element specimen NY1 (square and circular symbols used to distinguish between individual gages).

The results obtained from strain gages placed on the Y-stiffened element specimens are shown in Figures 6-8. These results were obtained from strain gages located on each specimen as shown in Figures 6a, 7a, and 8a. The circle and square symbols are used in Figures 6-8 to distinguish between individual gages and represent specimen failure. Strain gage results for the undamaged specimen NY1 are presented in Figure 6. The axial strain obtained from back-to-back gages located on the skin-flange region is shown in Figure 6b as a function of the applied load. The strain results presented in this figure exhibit slightly nonlinear behavior similar to the corresponding load-shortening behavior. No strain reversal is observed. Thus these results indicate that no bending or buckling occurred in the skin-flange region during the test. The axial (parallel to the load direction) and the transverse (perpendicular to the load direction) strain in the webs are shown in Figure 6c as a function of the applied load. Axial strains in each specimen web are shown for gage location B1 indicated in Figure 6a, and these strains are always compressive. Transverse strains in each web are shown for gage location B2, and these strains are always tensile. The axial strain results for the webs are similar to the axial strain results for the skin-flange region (Figure 6b). The transverse strain results for the webs show the onset of strain reversal indicating that the webs slightly bend or begin to buckle prior to failure. Axial strain results for the blade are presented in Figure 6d. These results are similar to the axial strain results for the skin-flange region and the web.

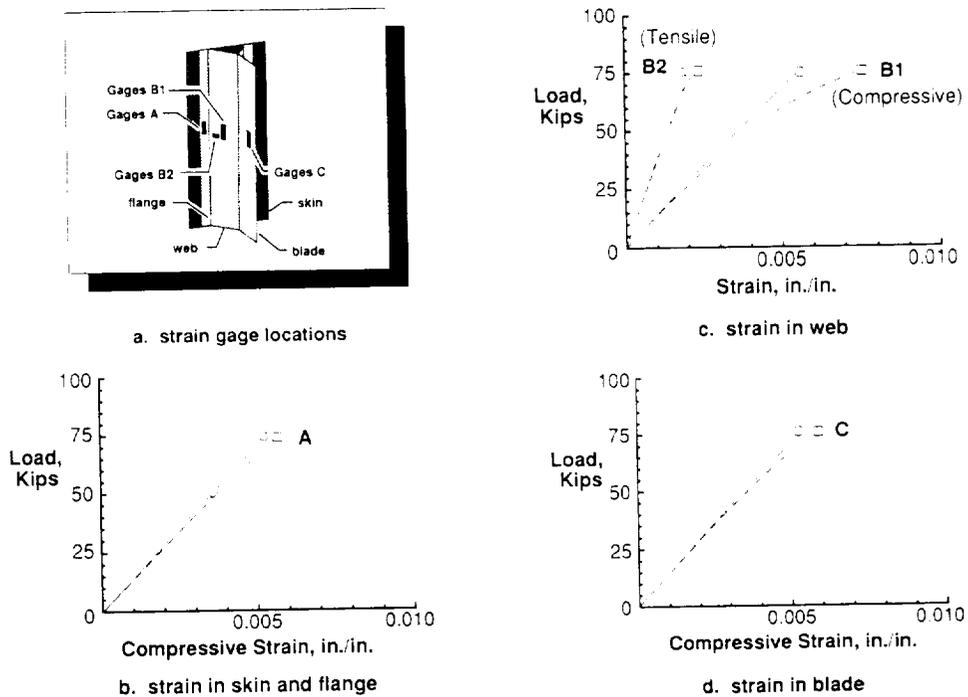
Figure 7. Strain gage results for impact damaged element specimen NY2 (square and circular symbols used to distinguish between individual gages).

Strain gage results for the impact damaged element specimen NY2 are presented in Figure 7. The axial strain from back-to-back strain gages located on the skin-flange region is shown in Figure 7b as a function of applied load. The slight differences in the back-to-back strains for a given load level indicate that local bending or buckling may be initiating. The axial and transverse strains in the webs are shown in Figure 7c as a function of the applied load. The compressive axial strain behavior is linear to failure for one gage and nonlinear for the other gage. The nonlinear strain behavior indicates bending of the web. The slight strain reversal observed for the tensile transverse strain results suggests that the webs buckle just prior to failure. The web transverse strain behavior for the damaged specimen is similar to the web transverse strain behavior for the undamaged specimen NY1, but the failure strain for the damaged specimen is less than the failure strain for the undamaged specimen. Axial strain results for the blade of specimen NY2 are presented in Figure 7d. These results are similar to the axial strain results for the skin-flange region of this specimen. All failure strains on Figure 7 for damaged specimen NY2 are less than the corresponding failure strains on Figure 6 for undamaged specimen NY1. However, the average failure strain for damaged specimen NY2 is greater than 0.0075 in./in. indicating good residual strength in spite of impact damage at the skin-flange region. Good residual strength is defined in this study as average failure strains greater than or equal to 0.006 in./in., in spite of the presence of impact damage.

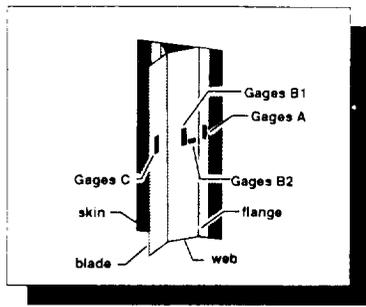
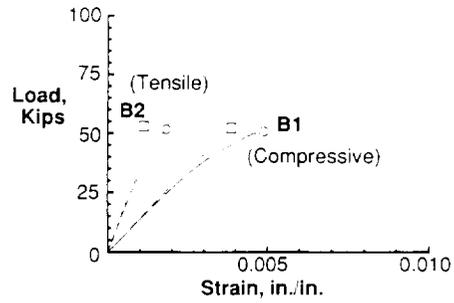
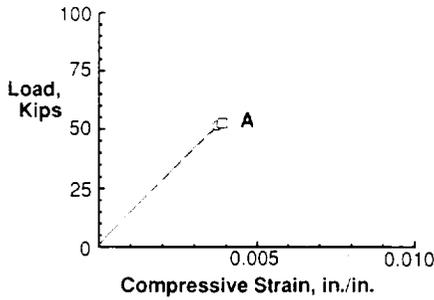
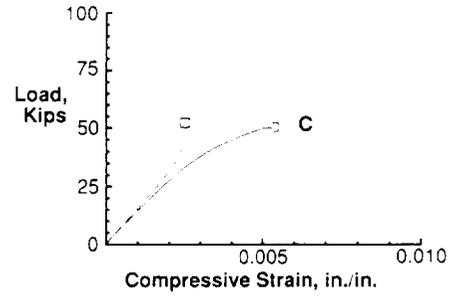
a. strain gage locations

c. strain in web

b. strain in skin and flange

d. strain in blade

Figure 8. Strain gage results for impact damaged element specimen NY3 (square and circular symbols used to distinguish between individual gages).

Strain gage results for the impact damaged element specimen NY3 are presented in Figure 8. The gage locations and orientations are shown in Figure 8a. The axial strain from back-to-back strain gages located on the skin-flange region is shown in Figure 8b as a function of applied load. These strain results are approximately linear to failure, and no strain reversal is observed. The axial and transverse strains in the webs are shown in Figure 8c as a function of the applied load. The compressive axial strain behavior is linear to failure for one web and nonlinear for the other web. The nonlinear behavior indicates bending of this web that is located adjacent to the impact damaged region. The strain reversal observed for the tensile transverse strain results indicates that these webs buckled prior to failure. The axial and transverse strain behavior of the webs of the damaged specimen NY3 is similar to the strain behavior for the damaged specimen NY2. Axial strain results for the blade of specimen NY3 are presented in Figure 8d. The strain reversal observed for these axial strains indicates that the blade buckles prior to failure. All failure strains on Figure 8 for specimen NY3 are less than the corresponding failure strains on Figure 7 for specimen NY2. These failure strain data, failure load data, and global failure strain results for specimens NY2 and NY3 indicate that, for the same impact energy, impact damage at the blade-web interface degrades the structural response of this Y-stiffener configuration more than impact damage at the skin-flange region. The average failure strain for damaged specimen NY3 is approximately 0.005 in./in. indicating marginal residual strength for this specimen with impact damage at the blade-web interface.

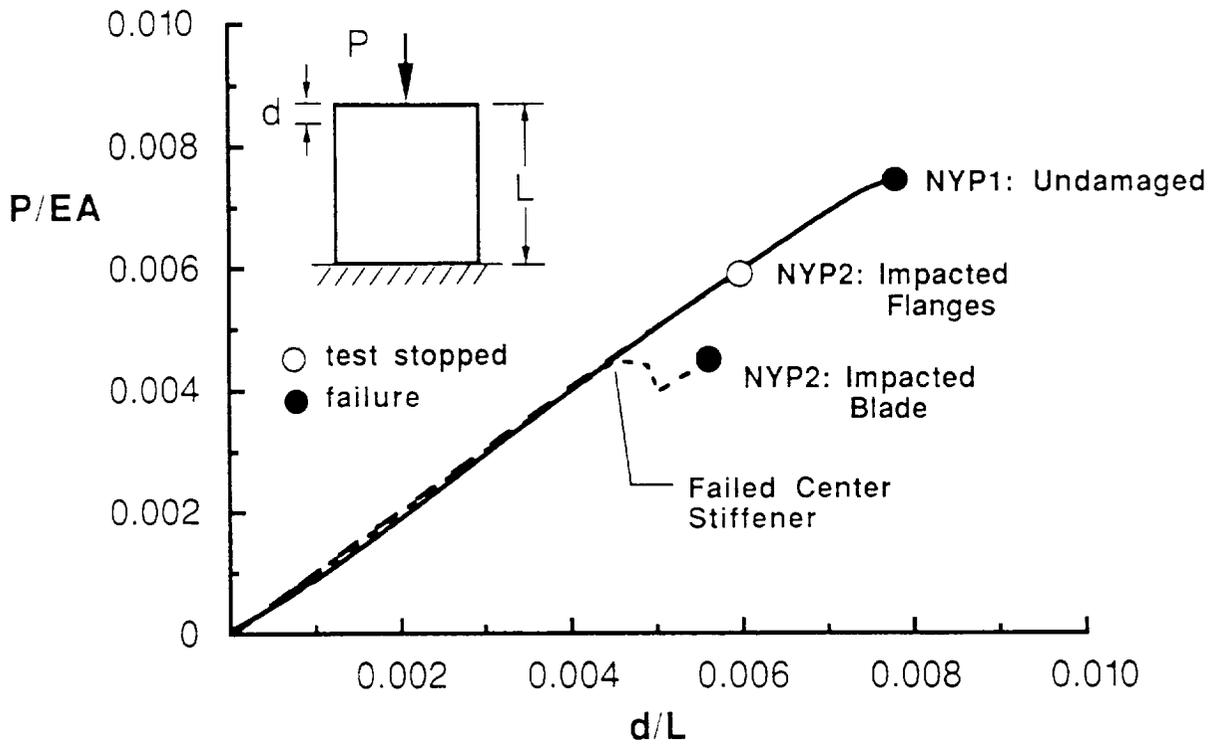
Figure 10. Normalized load versus end-shortening for Y-stiffened panel specimens.

Curves of normalized-load versus end-shortening results are presented in Figure 10 for the two Y-stiffened panel specimens. For the panels, the applied load P is also normalized by the membrane stiffness EA and the end-shortening d is also normalized by the specimen length L . The solid circles indicate failure of the specimen and the open circle indicates termination of the test prior to failure. All results appear nearly linear up to an average strain of approximately 0.005 in./in. The slight deviation from a linear response may be attributed to initial imperfections. Photographs of moire-fringe patterns just prior to specimen failure are shown in Figure 11. The photograph of the first specimen, NYP1, shown in Figure 11a indicates that the buckle pattern of the skin has five half-waves along the length and two half-waves across the width of the region between the stiffeners of the specimen. Specimen NYP1 failed at 285.2 kips, and an average strain level of 0.0078 in./in. The test of the second test specimen, NYP2, was conducted in two phases. First, NYP2 was impacted at two locations on the unstiffened side of the skin opposite the attachment flanges of the center stiffener, in a similar manner as Y-stiffened element NY2 (see Figure 4b). The panel was then loaded to a 0.006 in./in. average strain level to simulate the ultimate compressive strain level a wing cover panel is expected to experience in flight. The panel did not buckle or fail when loaded to an average strain level of 0.006 in./in. In the next phase of the test, NYP2 was impacted once more. The second impact site was located at the midpoint of the test section length and on the central blade in the vicinity of the transition region of the web and the blade (see Figure 4b). This location was determined to be the critical impact site from the previous tests of Y-stiffened element specimens. The panel was then loaded until the center stiffener failed. The failure load was 137.1 kips and corresponds to an average axial strain of 0.0045 in./in. The photograph of specimen NYP2 in Figure 11b shows that the buckling pattern of the skin has a single half-wave along the length and width of the central region between the outermost stiffeners. This mode shape occurred after the center stiffener separated from the skin but prior to separation of the skin from the remaining stiffeners. Specimen NYP2 failed when the skin debonded from the outer stiffeners at a load of 137.2 kips and an average strain of 0.0057 in./in. The maximum loading for the impact-damaged panel was 48 percent less than the maximum loading for the undamaged panel. The effects of damage on panel specimen failure are discussed below.

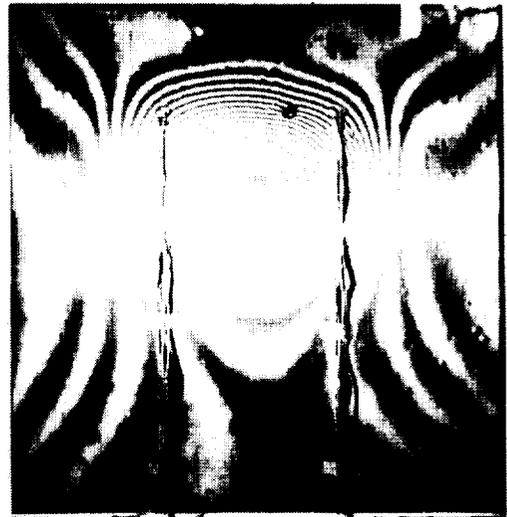
a. Specimen NYP1, $P = 283$ Kips
($P/P_{max} = 0.992$)

b. Specimen NYP2, $P = 137$ Kips
($P/P_{max} = 0.998$)

Figure 11. Photographs of moiré fringe patterns for Y-stiffened panel specimens.

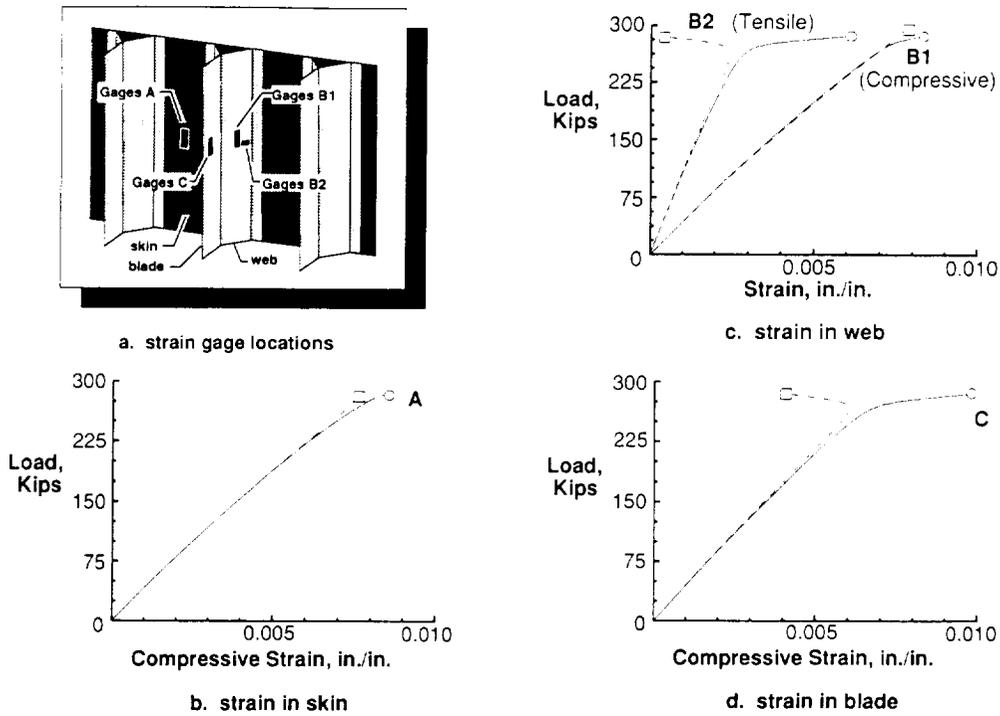
Figure 12. Strain gage results for undamaged panel specimen NYP1 (square and circular symbols used to distinguish between individual gages).

The strain gage results for the Y-stiffened panel specimens are shown in Figures 12 and 13. These results were obtained from strain gages located on each specimen as shown in Figures 12a and 13a. The circle and square symbols are used in Figures 12 and 13 to distinguish between individual gages and represent specimen failure. Strain results for the undamaged specimen NYP1 are presented in Figure 12. The axial strain obtained from back-to-back strain gages located on the skin between stiffeners is shown in Figure 12b as a function of the applied load. The results presented in this figure indicate slight nonlinear strain behavior similar to the nonlinear load-shortening behavior shown in Figure 10. No strain gage reversal is observed. These results indicate that a slight amount of bending occurs in this region just prior to failure. The axial and the transverse strain in the webs are shown in Figure 12c as a function of the applied load. Axial strains in each specimen web are shown for location B1, and these strains are always compressive like the axial strains obtained in the webs of the stiffened element specimens. Transverse strains in each web are shown for location B2, and, similarly, these strains are always tensile like the transverse strains found in the webs of the stiffened element specimens. Results of Figures 12b and 12c indicate that the axial strain in the webs is similar to the axial strain in the skin (Figure 12b). The transverse strain results for the webs clearly show strain gage reversal which indicates that the webs buckle prior to failure. Axial strain results for the blade are presented in Figure 12d. These results also show strain gage reversal which indicates buckling of the blade.

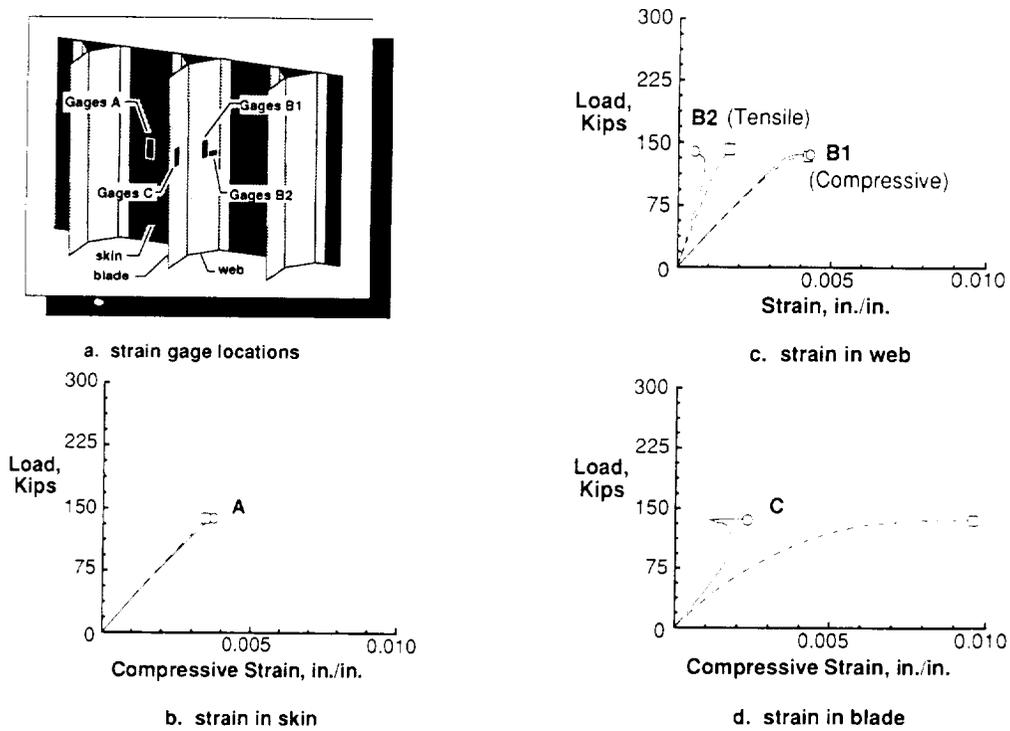
Figure 13. Strain gage results for impact damaged panel specimen NYP2 (square and circular symbols used to distinguish between individual gages).

Strain gage results for the impact damaged panel specimen NYP2 are presented in Figure 13. These results correspond to the second phase of the test in which the panel was loaded to failure. All results obtained in the first phase of the test are linear and have the same slope as the initial slope of the corresponding load versus strain curves obtained in the second phase of the test. The axial strain obtained in the second phase of the test, from back-to-back strain gages located on the skin between stiffeners, is shown in Figure 13b as a function of applied load. These strain results show only a slight indication of local bending in the skin. The axial and transverse strains in the webs are shown in Figure 13c as a function of the applied load. These compressive axial strain results indicate that buckling of both webs has occurred. The strain gage reversal observed for the tensile transverse strain results occur at a strain level of 0.0005 in./in. and indicates that these webs buckled prior to failure. Axial strain results for the blade of specimen NYP2 are presented in Figure 13d. The strain gage reversal observed for these axial strains indicates that the blade of the impact damaged specimen buckles at a much lower load level than the blade of the undamaged specimen. The significant difference in the strains of the back-to-back strain gages suggests that buckling of the blade may have caused a midplane interlaminar shear failure of the blade. All failure strains on Figure 13 for specimen NYP2 are less than the corresponding failure strains on Figure 12 for specimen NYP1. The average axial failure strain for the damaged specimen NYP2 is approximately 0.0057 in./in., indicating marginal residual strength of this panel subjected to a combined impact at the skin-flange region and at the blade-web interface.

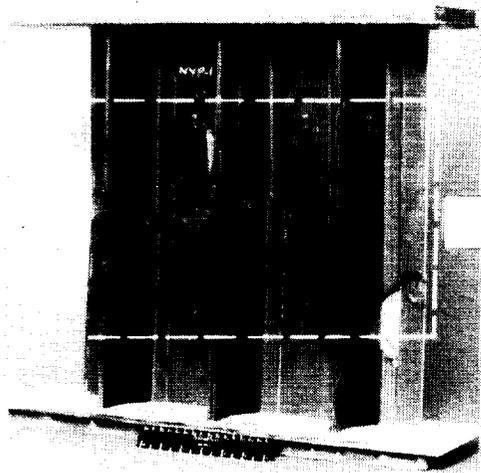
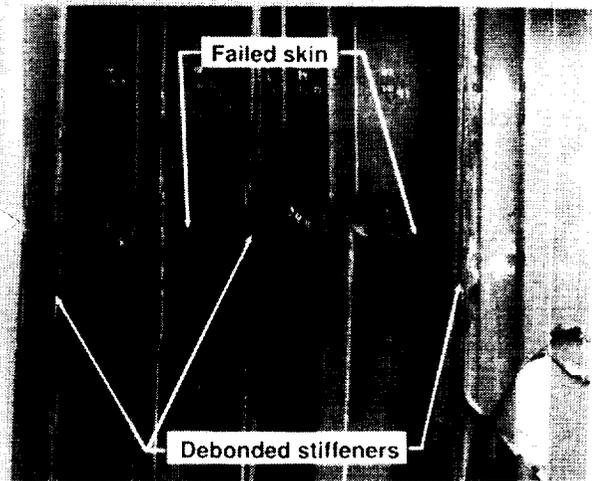
Failed panel specimen NYP1

Failure region

Figure 14. Failure mode of Y-stiffened panel specimen NYP1.

Photographs of the failed panel specimens NYP1 and NYP2 are shown in Figures 14 and 15, respectively. Both specimens failed in the test section of the panel. The damage, as a result of failure, appears to be more severe in specimen NYP1 than in specimen NYP2. This difference is due to the much higher failure load of specimen NYP1. The strain results for these panel specimens indicate that buckling of both the web and blade occurs. These results, however, do not conclusively indicate which element buckles first. The results do reinforce the idea that web buckling and blade buckling are important design considerations for Y-stiffened panels.

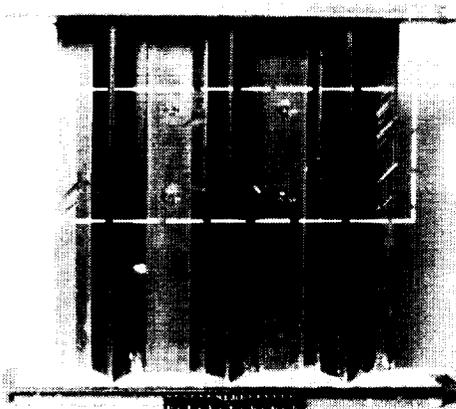
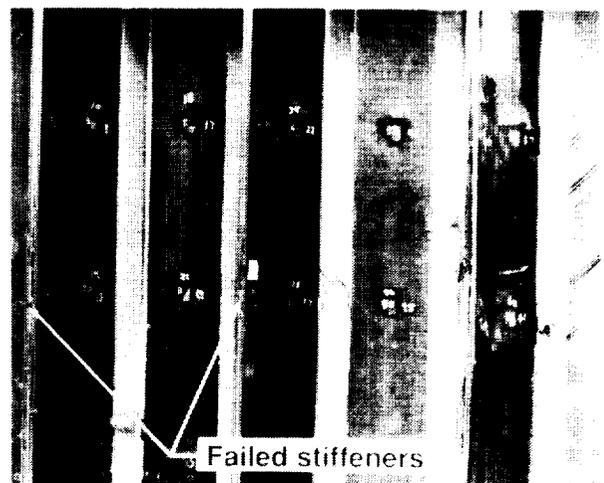
Failed panel specimen NYP2

Failure region

Figure 15. Failure mode of Y-stiffened panel specimen NYP2.
